The Effects of Precipitation Static and Lightning on the Airborne Reception of LORAN-C

Volume I (Analysis)

James D. Nickum

Avionics Engineering Center
Department of Electrical Engineering
Ohio University
Athens, Ohio 45701

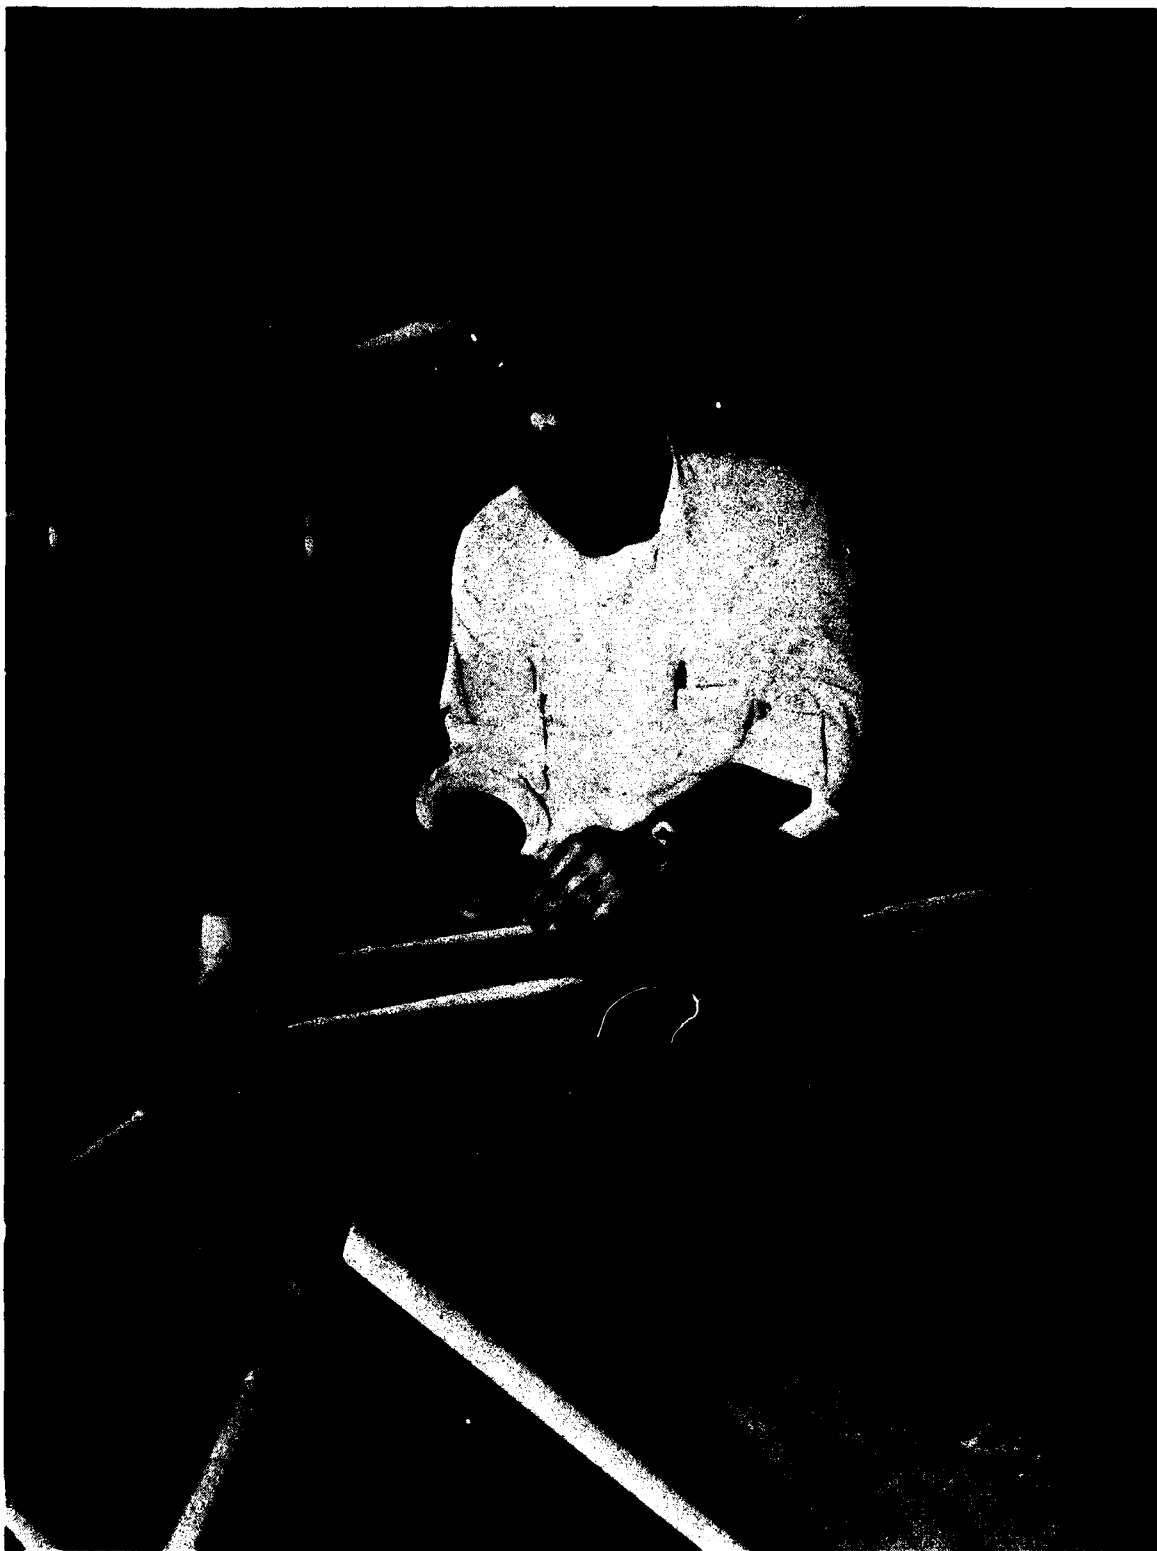
Figure 3-6. Close-Up of Ion Collection Fixture and Dayton-Granger Dischargers.
